# Keeping Bloxwich Active Living Centre Running Smoothly

Bloxwich Active Living Centre

Multiple Grundfos  
Twin Circulators

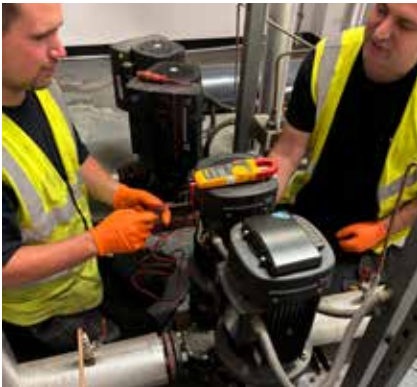
Electrical testing of equipment

Units showing alarm lights were thoroughly checked and tested to confirm there were no underlying issues, giving the client confidence that the equipment was safe to run.

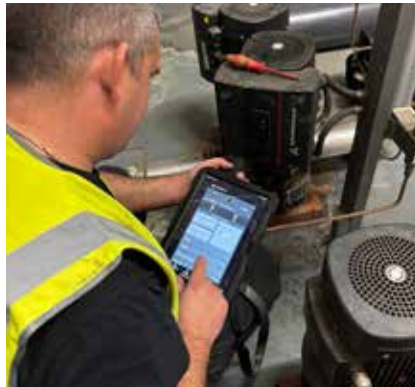
Parameter checks

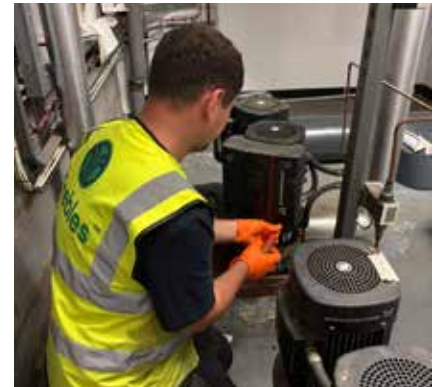
Disassembling the pump

One circulator pump with a leaking mechanical seal was identified and replaced, restoring reliable operation.

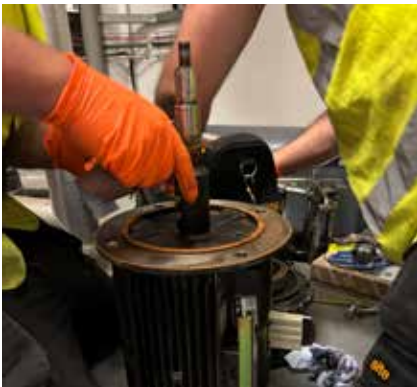
Inspection of stub shaft

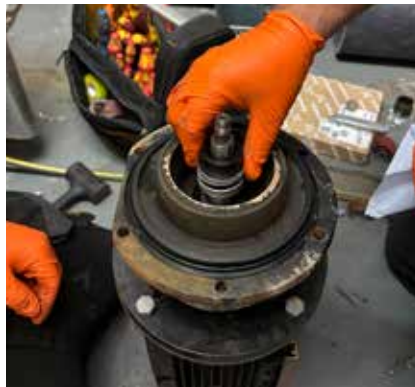
Replacing the mechanical seal

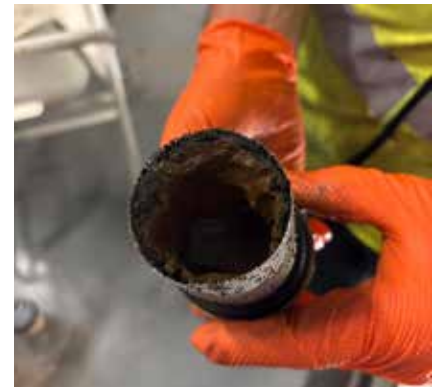
A noisy circulator pump was found to be cavitating due to a heavily clogged strainer restricting water flow. The team cleaned and replaced the strainer, ensuring proper flow to the system.

Strainer (Before)

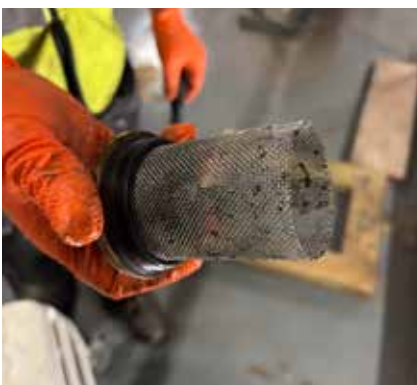
Strainer (After a good clean)

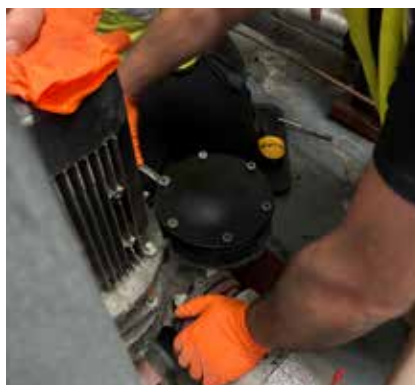
Installation of blanking plate

To prevent further damage, the noisy pump was removed and replaced with a blanking plate. This allowed Trebles' engineers to return the pump to the service department for a detailed inspection. Early indications suggested possible wear ring and bearing damage, but full confirmation would come from a complete strip-down and assessment.

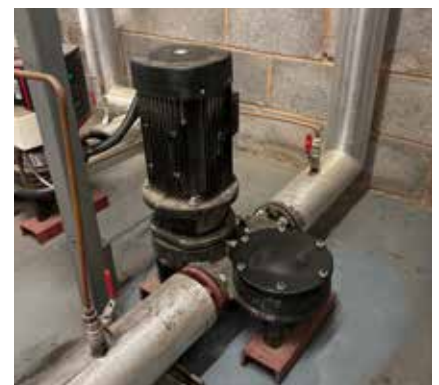
Blanking plate installed
